LOWER CONNECTICUT RIVER BASIN
EAST HADDAM , CONNECTICUT

BASHAN LAKE DAM
CT 00354

PHASE I INSPECTION REPORT
NATIONAL DAM INSPECTION PROGRAM

FEBRUARY 1979

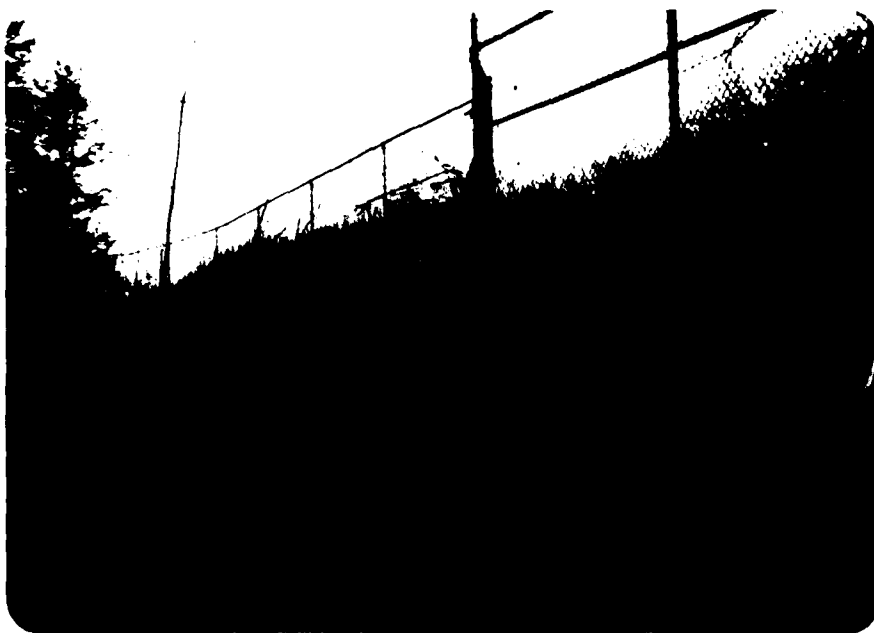
Due to the significant discharge of this area, there is a possibility that movement and initial failure of these spillway blocks could initiate further failures of the downstream granite block wall and possibly of the dam itself.

PHOTO NO.2 - Downstream view of spillway and downstream face of dam.
